Canal &  
River Trust

## **LIFT BRIDGES – OXFORD CANAL**

### **HERITAGE REPORT**

October 2014

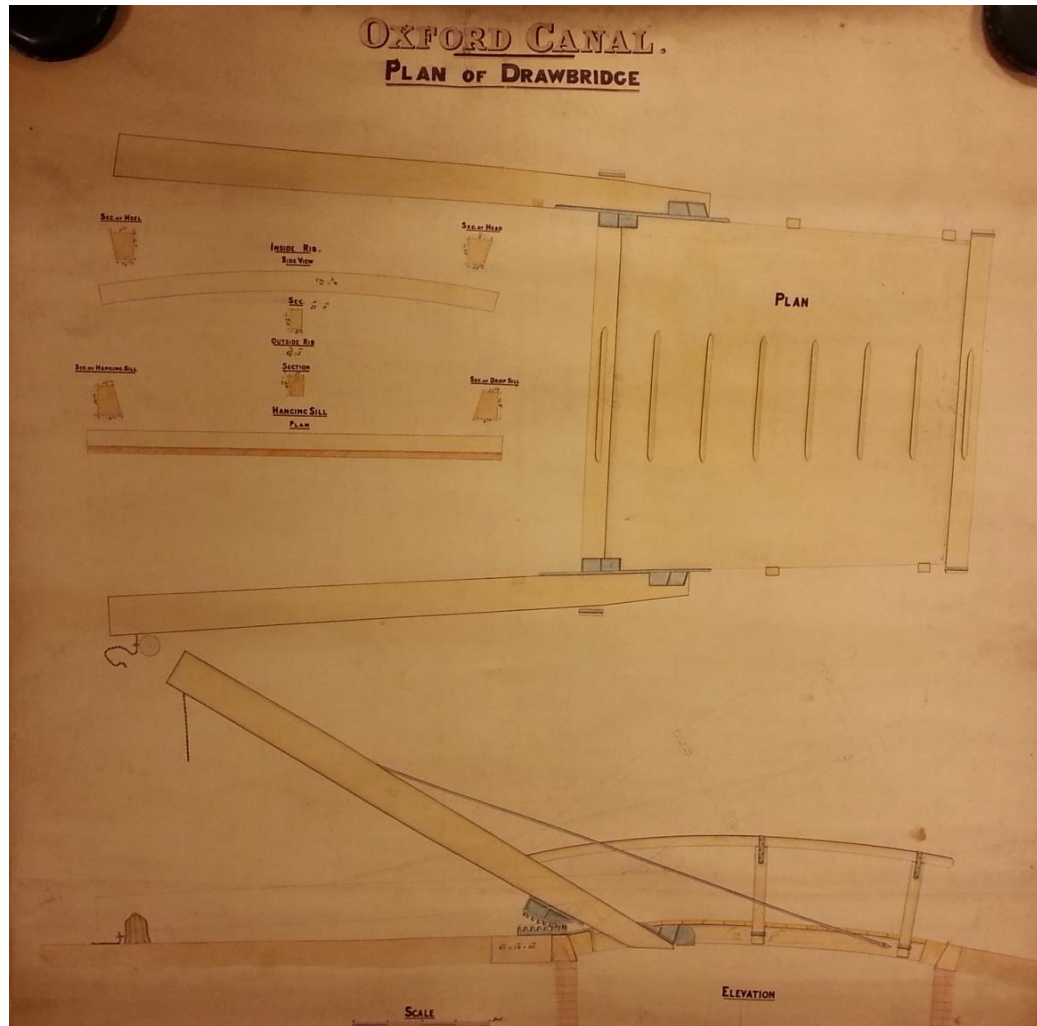
**Warwick county archive  
ref CR1590/P255**

Drawing not dated. Archive dates it to 1859 but typography might indicate an early 20<sup>th</sup> century drawing instead.

Note curvature of the deck and handrail and grip provision on the deck.

Given the timber lift bridges are of a unique design to the Oxford, and have very simple lines these also have strong **aesthetic values**. Although archive research has revealed that the bridge design has evolved over time with the current flat deck depicted in the early 20<sup>th</sup> century as being curved. (see drawing in appendix).
